**Flood Control Project Maintenance  
Levee Inspections**

**Fall 2015 Levee Maintenance Deficiency Summary Report**

**Sacramento Maintenance Yard East Levee Yolo Bypass**

**Levee Inspection Report By Mile - Fall 2015**

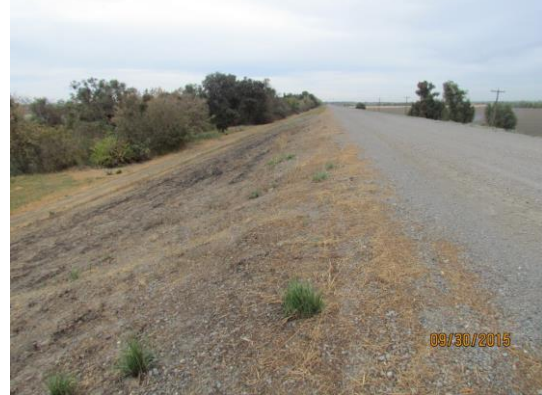
Photo 1 of 1 : FA\_2015\_ST0004\_41\_1\_20151005\_00002.jpg

LM Start	0.00	Rating **	A	Issue No.	1
LM End	2.02	Issue Type +	Ma	Location *	WS
Category	Earthen Levee			GPS Latitude/Longitude	
				Start	End
Item	Vegetation			38.765290 °	38.736216 °
				-121.635073 °	-121.633685 °
DWR ID	DWR_ST0004_01_f_2015_1				
Action/Comments					
Control annual grass and weeds on the levee slopes and easements. Inspector Comments: Vegetation on slope has been burned.

View of the vegetation on the waterward side of the levee looking upstream. Fall 2015.

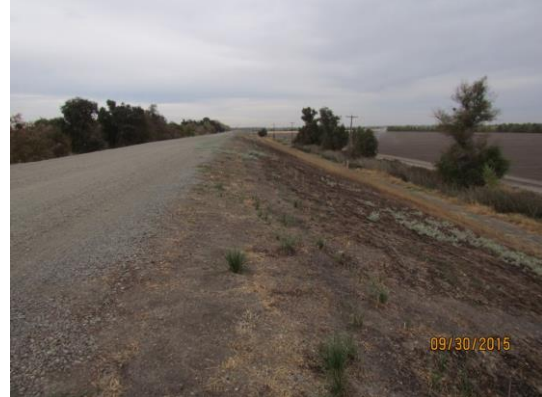
Photo 1 of 1 : FA\_2015\_ST0004\_41\_2\_20151005\_00003.jpg

LM Start	0.00	Rating **	A	Issue No.	2
LM End	2.02	Issue Type +	Ma	Location *	LS
Category	Earthen Levee			GPS Latitude/Longitude	
				Start	End
Item	Vegetation			38.765288 °	38.736216 °
				-121.635073 °	-121.633684 °
DWR ID	DWR_ST0004_01_f_2015_2				
Action/Comments					
Control annual grass and weeds on the levee slopes and easements. Inspector Comments: Vegetation on slope has been burned.

View of the vegetation on the landward side of the levee looking upstream. Fall 2015.

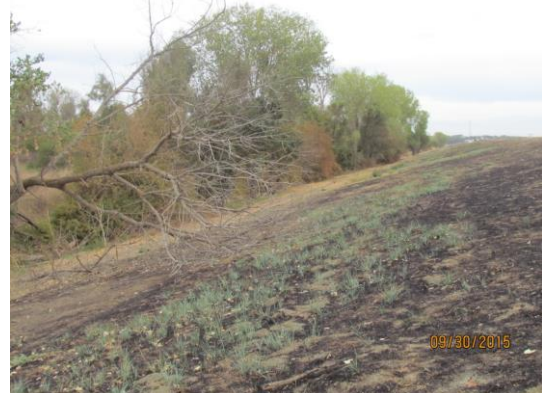
Photo 1 of 2 : FA\_2015\_ST0004\_41\_7\_20151005\_00005.jpg

LM Start	1.42	Rating **	M	Issue No.	7
LM End	1.42	Issue Type +	Ma	Location *	WS
Category	Earthen Levee			GPS Latitude/Longitude	
				Start	End
Item	Encroachments			38.744863 °	38.744863 °
				-121.634251 °	-121.634251 °
DWR ID	DWR_ST0004_01_f_2015_7				
Action/Comments					
Tree or limb

Perspective view of the broken tree on the waterward side of the levee looking upstream. Fall 2015.

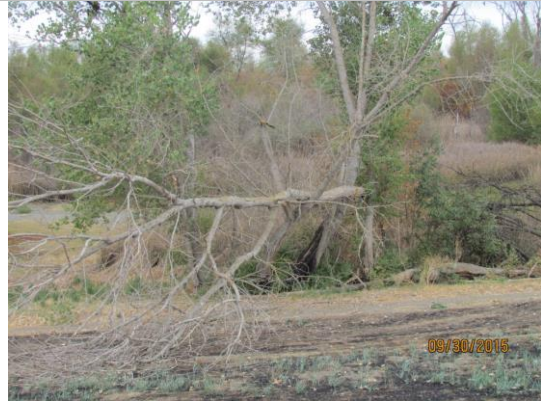
Photo 2 of 2 : FA\_2015\_ST0004\_41\_7\_20151005\_00007.jpg

LM Start	1.42	Rating **	M	Issue No.	7 (cont)	
LM End	1.42	Issue Type +	Ma	Location *	WS	
Category	Earthen Levee			GPS Latitude/Longitude		
				Start		End
Item	Encroachments			38.744863 °		38.744863 °
				-121.634251 °		-121.634251 °
DWR ID	DWR_ST0004_01_f_2015_7					
Action/Comments						
Tree or limb

The tree is broken on the waterward side of the levee. Fall 2015.

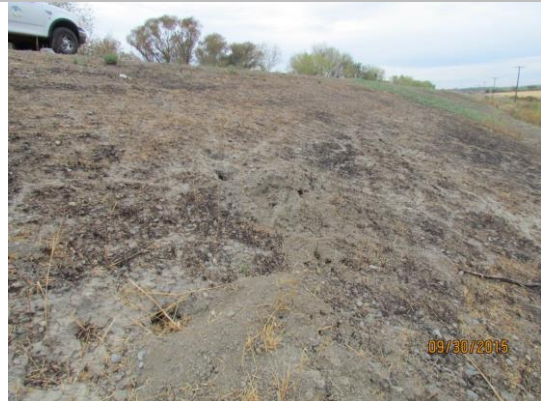
Photo 1 of 1 : FA\_2015\_ST0004\_41\_6\_20151005\_00004.jpg

LM Start	1.65	Rating **	M	Issue No.	6
LM End	1.65	Issue Type +	Ma	Location *	LS
Category	Earthen Levee			GPS Latitude/Longitude	
				Start	End
Item	Animal Control			38.741579 °	38.741579 °
				-121.634007 °	-121.634007 °
DWR ID	DWR_ST0004_01_f _ 2015_6				
Action/Comments					
No rodents visible, but rodent burrows visible; need to backfill and compact or grout burrows.

View of the rodent holes on the landward side of the levee looking upstream. Fall 2015.
